# THE GOOD(ish), THE BAD, THE UGLY - AND THE CONTRASTING DUNE MANAGEMENT OPTIONS

Contrasting the effects of a severe onshore (easterly) storm on 9/10 July 2014 – at OREWA & PAPAMOA Beaches

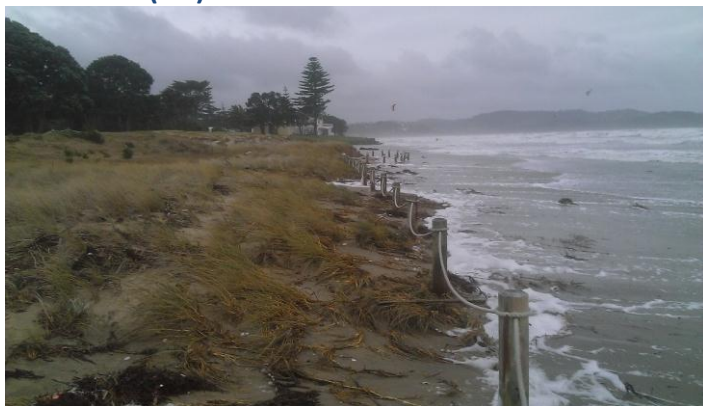
## THE GOOD(ish): Orewa

This dune area has been ‘modestly’ restored at low cost (utilising **only one** of the existing **four indigenous** dune plant species) but this area displays some restored storm resilience, so is still capable of resisting some of the erosional effects of these storm-surges, **caused by the 3-4metre maximum wave height** conditions. Stolons of these spinifex plants are still present seaward of the barrier and will resume active growth when conditions improve, additionally boosted by the nutrients provided by decaying seaweed delivered naturally by these stormy conditions.

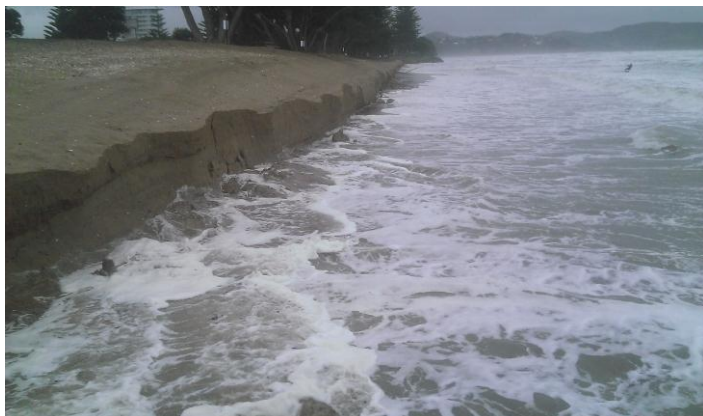
## THE BAD: Orewa

In this case, sand has simply and repeatedly been dumped on this eroding dune (costing >\$50,000 per annum) - with the **same result every time – active erosion**. This work is described as beach nourishment, known globally as an excessively expensive method of simply delaying the inevitable. This is undertaken without any consideration of the obvious problem – coastal ecosystem degradation. The **only** sustainable response here is transformation of the degraded dune by assiduous restoration of the original halophyte indigenous sand-trapping and dune-building plants.

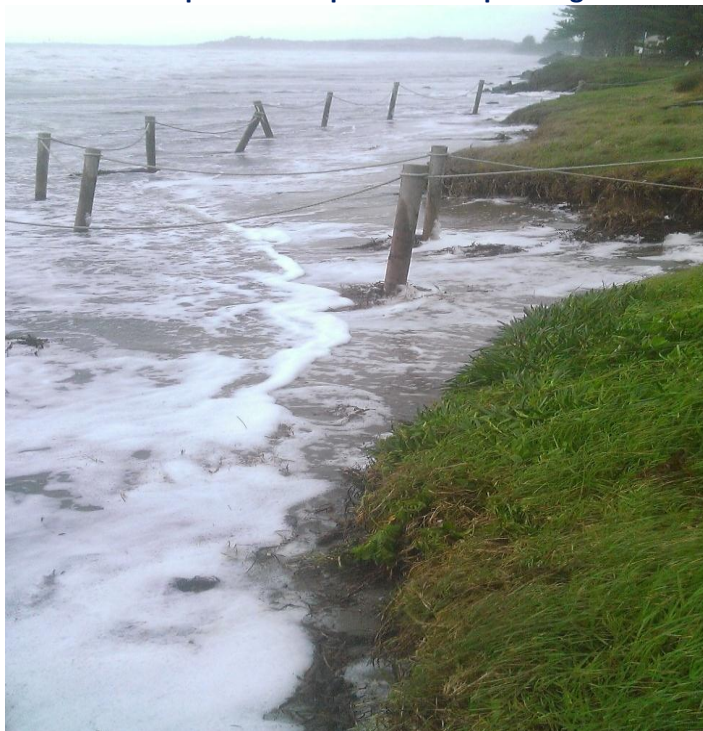
## THE UGLY – a prime example of token planting and management: Orewa

An initial and probably eager burst of ‘fashionable’ dune planting at this northern end was both poorly considered and maintained – resulting in the whole area becoming overrun by salt-susceptible weed species and so losing any briefly improved resilience to storm surges. Predictably, the whole planting has now eroded back to this weedy bank. That problem will continue now, further degrading this beach and weedy bank, exposing nearby houses to increasing risk. Posts should now be removed along with the redundant and insincere “Dune Protection” signs, as this area is not attracting any new or assiduous restoration attention. This modest or token coastal planting at Orewa contrasts markedly to the thorough and transformational restoration at Papamoa, shown on the following page, **in a photo taken during the same storm**.

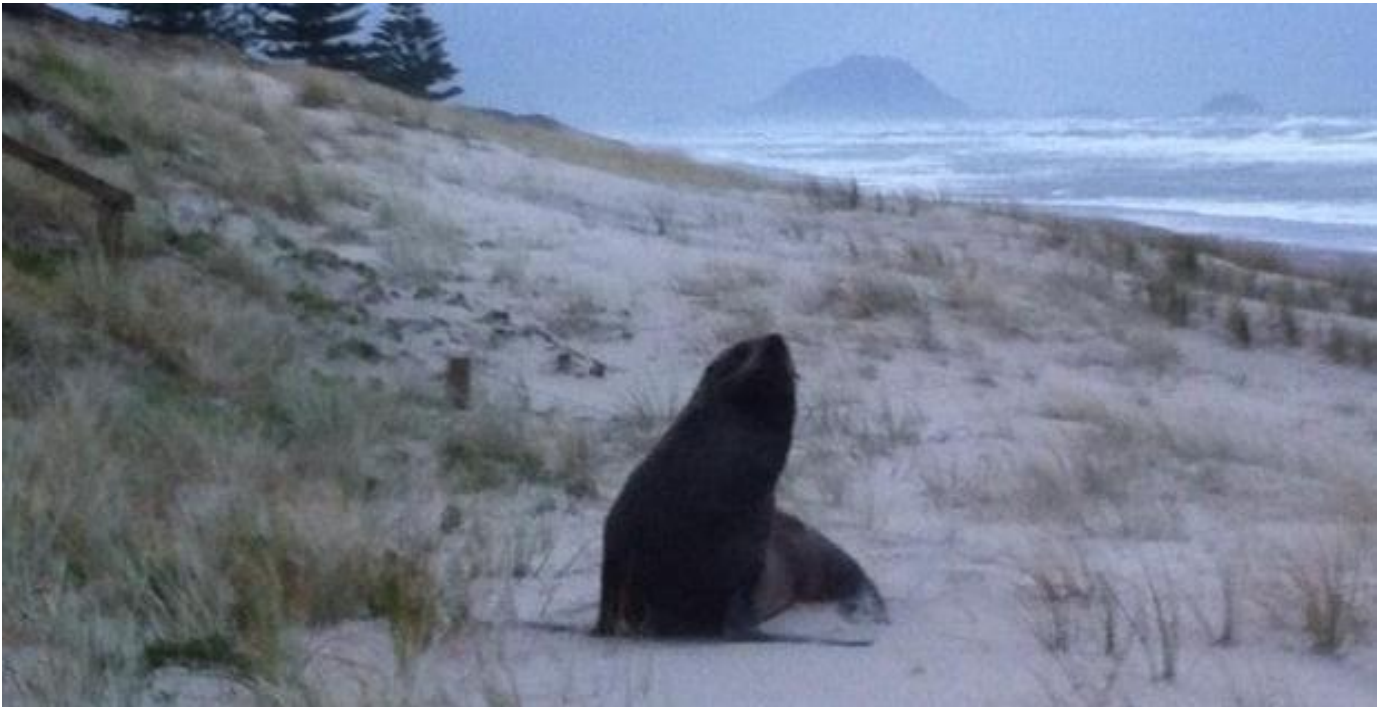
## AND THE CONTRASTING DUNE MANAGEMENT OPTION - the impact of Assiduous Restoration: Papamoa

This beach and dune have been transformed from earlier domination by the introduced and inferior marram grass, which proved to not tolerate salt water contact. This assiduously restoration using the simple and systematic techniques is described as “**A-Rest Systems**”. Importantly, at least two species of our indigenous and **salt-tolerant** foredune plant species have been successfully established here - to provide sustainable long-term sand accumulation results that also enhance biodiversity values. And so the seal pictured above (and other native fauna) can safely seek refuge here from storms - and people - on this increasingly wide beach and dune.

Even during these storm surge conditions (**with maximum wave height of 7.6 metres**; measured by the BOP Regional Council wave buoy) sand is still being accumulated by these very effective salt-tolerant plants, unaffected by any encroaching weeds or other unnatural and damaging influences. Weed invasion is easily controlled at the landward margin of such dunes, and by continuing simple vigilance of the seaward face.

**ANALYSIS:** Both of these North Island east coast beaches were exposed to the same onshore storm conditions and over the same time period. Orewa beach has suffered considerable erosional effects, while the wave climate at Orewa is markedly less energetic – 4m maximum wave height vs 7.6 m at Papamoa. The smaller swells here are attributable to the relatively shallow depth of the adjacent Hauraki Gulf and its many islands, naturally providing increased shelter from larger on-shore storm settings. **So why does Orewa beach exhibit increased erosion??** This problem is principally due to one singular factor – poor foredune condition. Human-induced impacts at Orewa have clearly **not** been resolved successfully, in contrast to the Papamoa dunes. Papamoa is clearly also exposed to more severe wave heights (7.6m in this July storm) rolling in through deeper and more exposed ocean conditions, which result in higher wave energies impacting on these dynamic beach systems, protected now by visibly increased resilience provided by **A-Rest Systems** restoration. Additionally, recent data gathered from assiduous restoration sites at Papamoa beach show that this transformation option will completely off-set the effects of +118cm of sea level rise predicted by the IPCC 5 AR through to at least year 2100, by the SimCLIM2013 Coastal Erosion computer model. Orewa beach will **not** enjoy this same advantage.
